MOISIO RESIDENCE

2101 CLARKE STREET, PORT MOODY
(FORMERLY 2614 ST. JOHNS STREET)

CONSERVATION PLAN

NOVEMBER 2015 REVISED JULY 2016

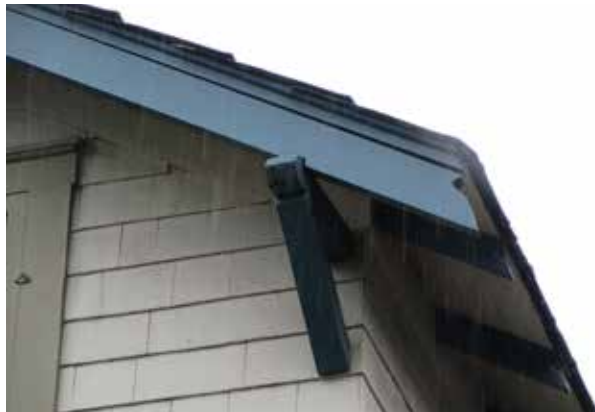
Original wood trim is visible on the elevations including window and door trim, fascia boards and bargeboards, and watertable which should be preserved and repaired in-situ. Severely damaged or deteriorated trim and other original woodwork can be replaced in kind.

Bargeboard with notched ends

- Original trim that is in good or repairable condition may be retained, including window and door trim, fascia boards and bargeboards, and watertable.
- Cut out deteriorated trim sections and install matching trim board that is visually and physically compatible with the original.

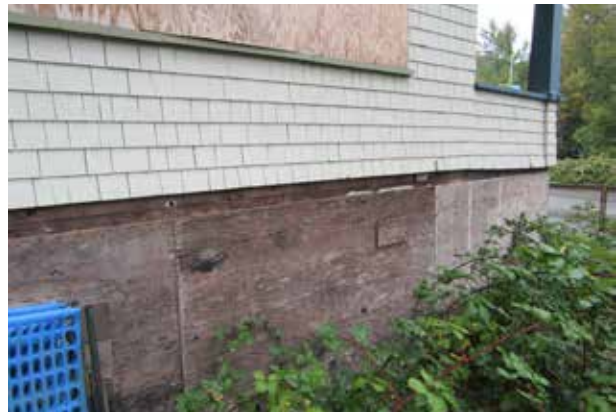
The original cedar shingle siding on the main and upper floors is in place and in good condition except for peeling paint. At the basement level, cedar shingles were originally installed, but removed during the relocation process. The cedar shingle siding may

be preserved and restored. Severely damaged cedar shingle siding can be replaced with appropriate replica siding matching the original profile. The basement will be rehabilitated and new cedar shingles similar to the original may be installed.

Cedar shingles on main floor and plywood at basement level

- Retain cedar shingle siding and restore in-place where possible. Replace any damaged cedar shingle siding to match existing in material, size, profile.

- Combed or textured lumber, vinyl or fibre cement siding are not acceptable replacement materials on the historic house.
- Cleaning procedures of cedar shingle siding should be undertaken with non-destructive methods. Areas can be cleaned using a soft, natural bristle brush, without water, to remove dirt and other material. If a more intense cleaning is required, this can be accomplished with warm water, mild detergent (such as Simple Green) and a soft bristle brush. High-pressure power washing, abrasive cleaning or sandblasting should not be allowed under any circumstances on any historic material of the exterior elevations.

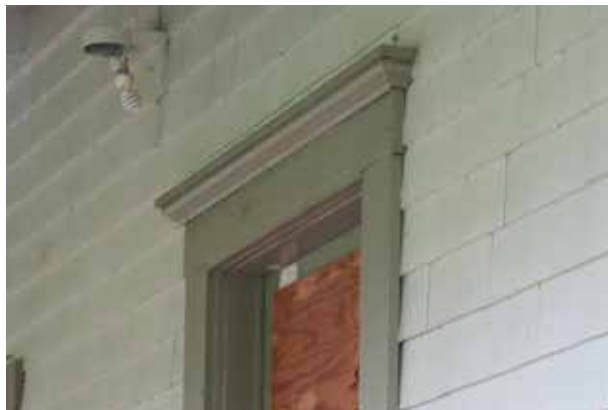
Door trim

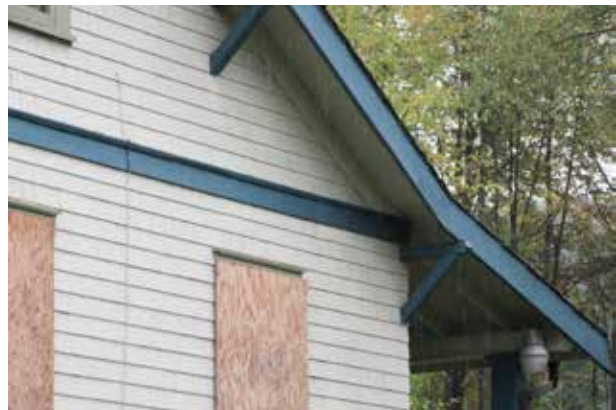
Belt course separating the main and upper floors

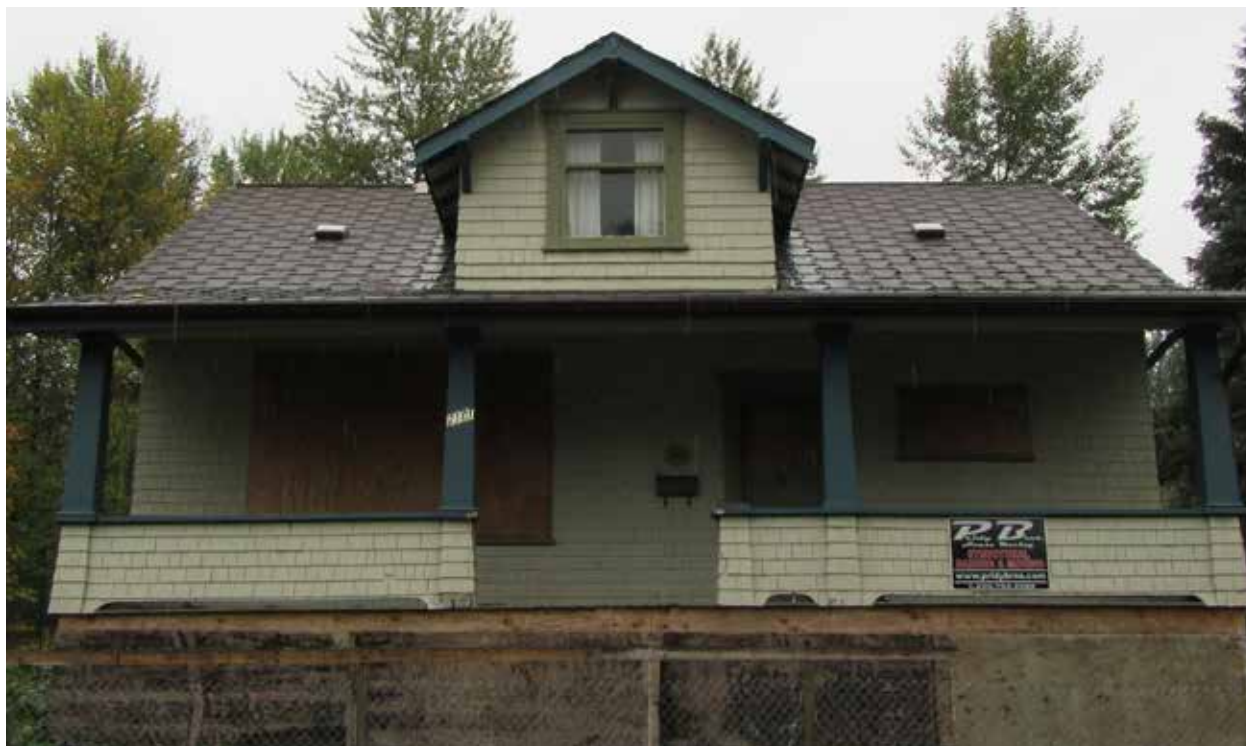
The Moisio Residence features two original verandahs running the full length of the front and rear sides of the house. Both verandahs have very similar configurations consisting of four tapered timber columns with small capitals supporting the verandah roofs, extensions of the main side-gabled roof. The sloping verandah ceilings feature exposed rafter tails and tongue-and-groove soffits. An architectural detail are notched bargeboards. The closed and shingled balustrades have solid wood sills and drainage scuppers.

While the front verandah retained the tongue-and-groove decking, the original flooring of the rear verandah was replaced with plywood. A further distinction is that the front verandah is accessed at the mid-section, while the rear verandah is accessible from one side. The wooden stairs leading to both verandahs were removed prior to moving the structure. They can be replaced with new wooden stairs and handrails that are sympathetic to the historic character of the house.

Front verandah with closed and shingled balustrades

- Preserve the front and rear verandahs as important architectural elements of the house.
- Move both verandahs with the main structure to its permanent location, if possible.
- Restore original verandah elements that are in good condition where feasible, including tapered columns with capitals and rounded base, wooden sills, exposed rafter tails and tongue-and-groove soffits.
- The closed and shingled balustrades with drainage scuppers can preserve their original detailing and height. Building code requirements can be met with alternate compliance method, e.g. installing glass panels or metal railings to meet the required height. The Heritage Consultant can advise on the design.
- Design new wooden front and rear stairs with closed treads and risers. The Heritage Consultant can advise on the design.

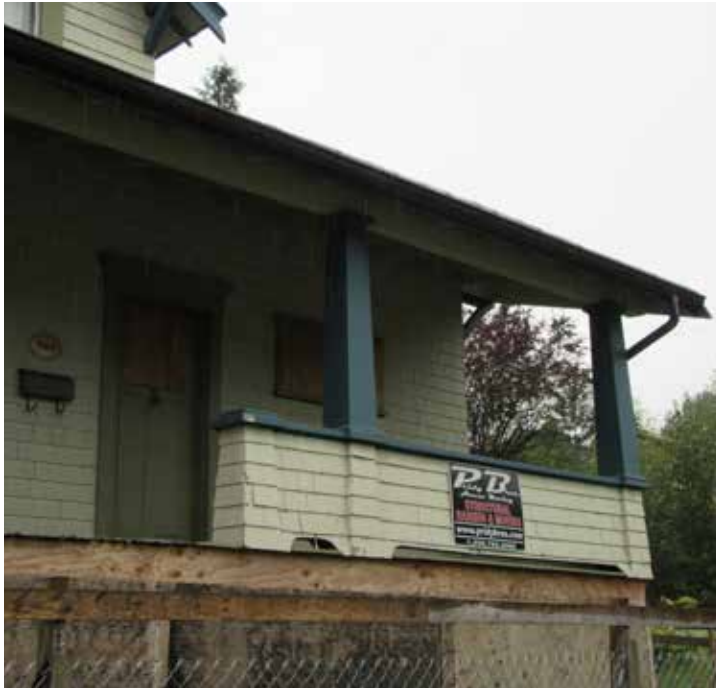
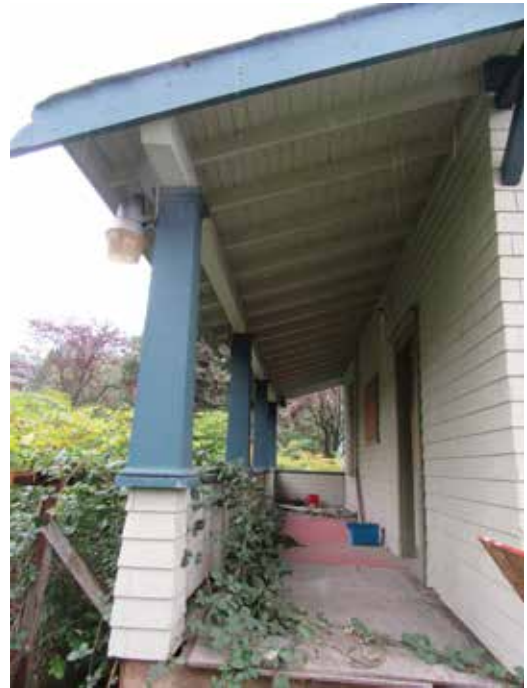
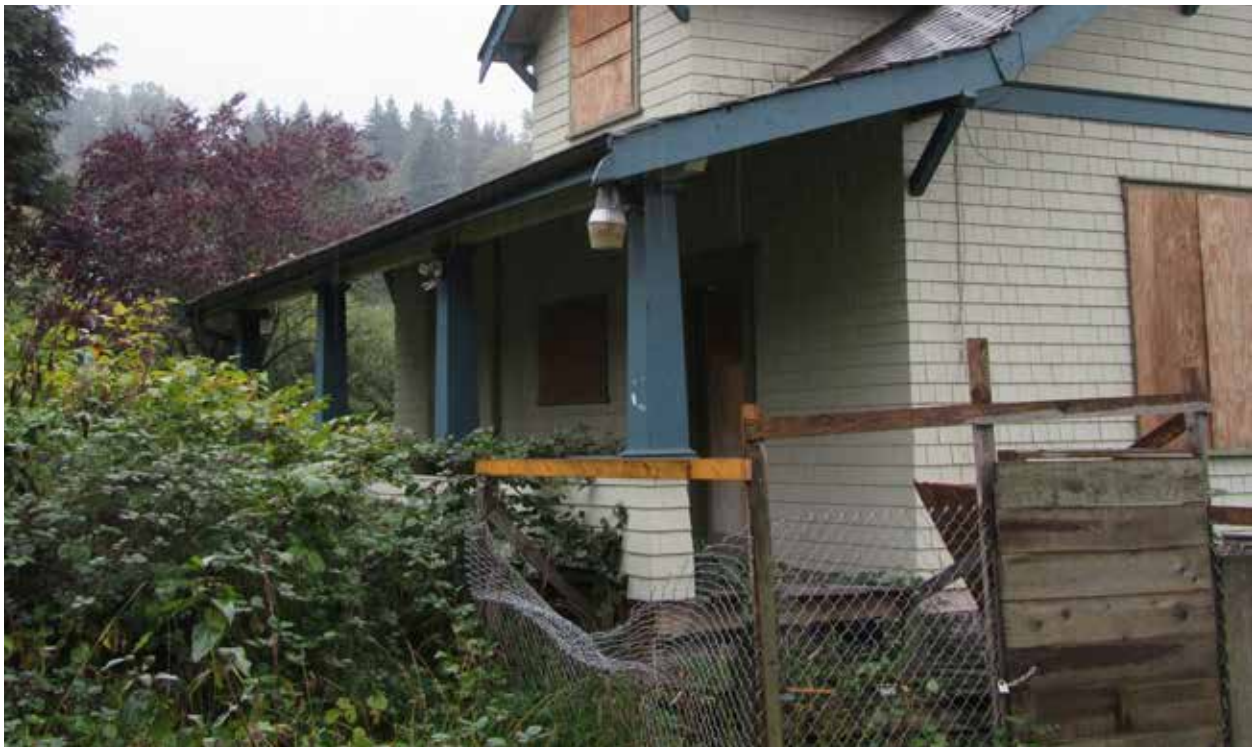
Top Left: Front verandah with tapered columns Top Right: Rear verandah ceiling featuring exposed rafter tails and tongue-and-groove soffits; Bottom: Rear verandah

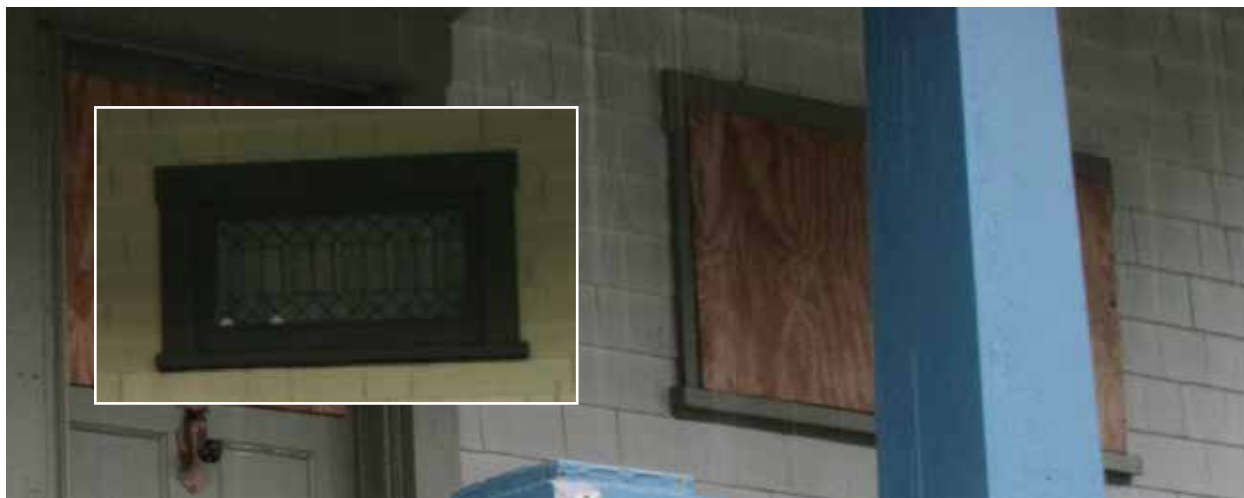
The original windows of the Moisio Residence are still in place and consist of single, paired and triple sets of one-over-one, double-hung wooden sash windows on the main floor. This floor also features a piano window with leaded glass on the front facade and a narrow sliding window with two sashes on the rear elevation. All windows on the main floor are currently boarded up.

Front verandah with inset piano window

- Retain all original wood sash windows and surrounding trim in their original openings where possible. Deteriorated or damaged wood elements may be restored (e.g. sashes, trim, sills). Missing or deteriorated elements can be replaced.

- Overhaul, tighten/reinforce joints of original windows where possible. Repair frame, trim and hardware. Each original window can be made weather tight by re-puttying and weather-stripping as necessary.

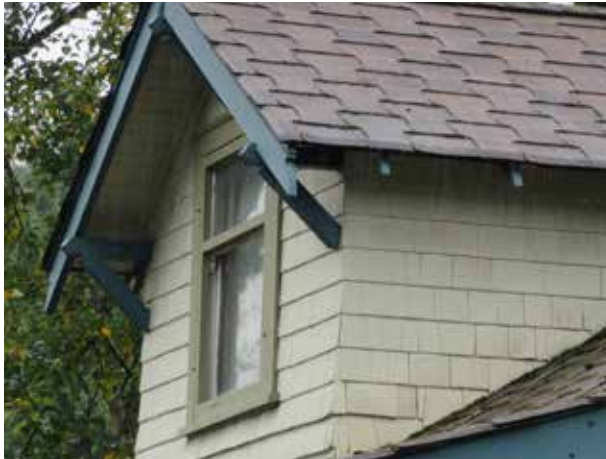
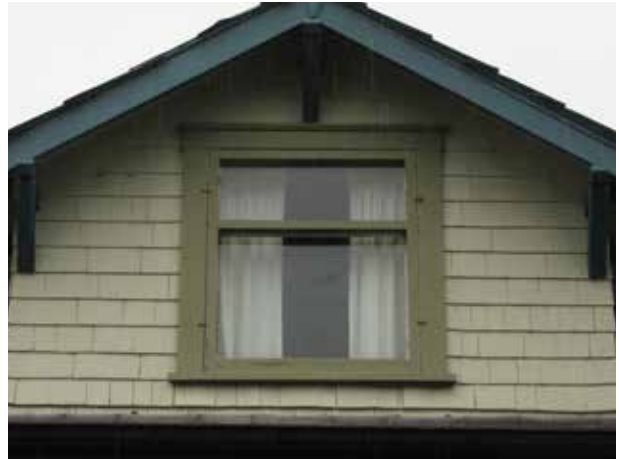
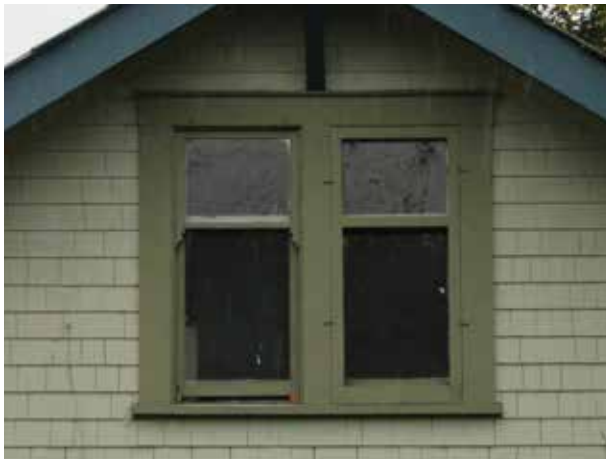
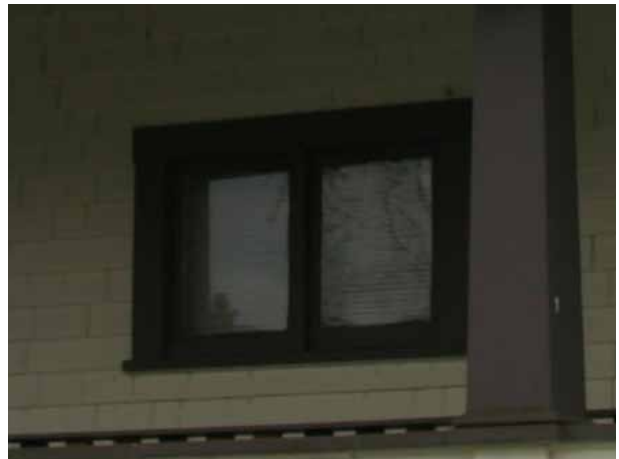
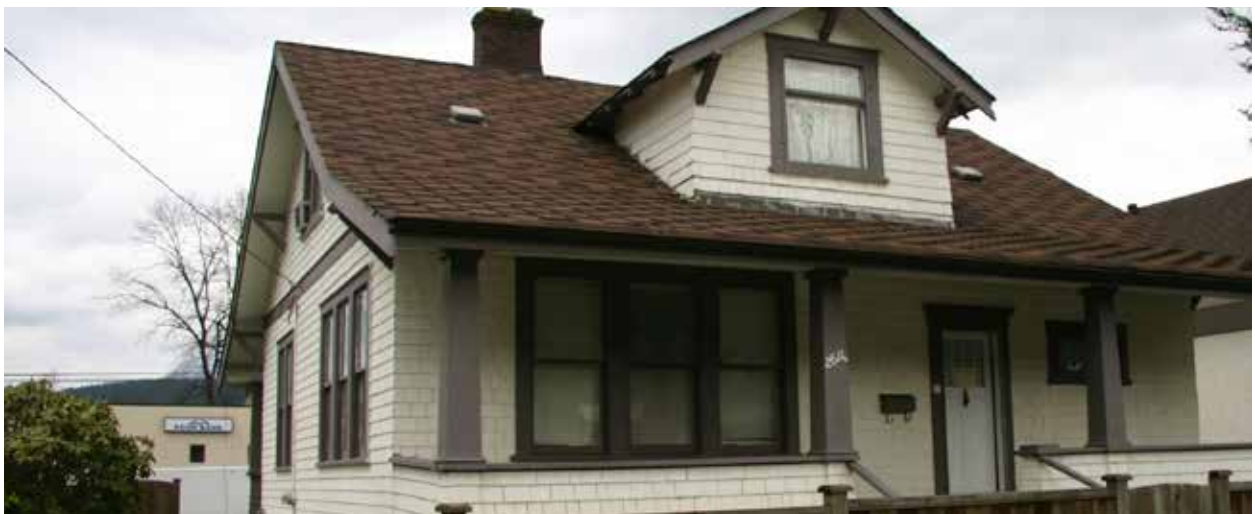
Typical windows of the Moisie Residence

- Window restoration should be undertaken by a contractor skilled in heritage restoration.
- New windows at the basement level can be made of wood and the design should respectful to the historic character of the house.

- Prime and paint all wood windows as required in appropriate colours, based on colour schedule devised by the Heritage Consultant.

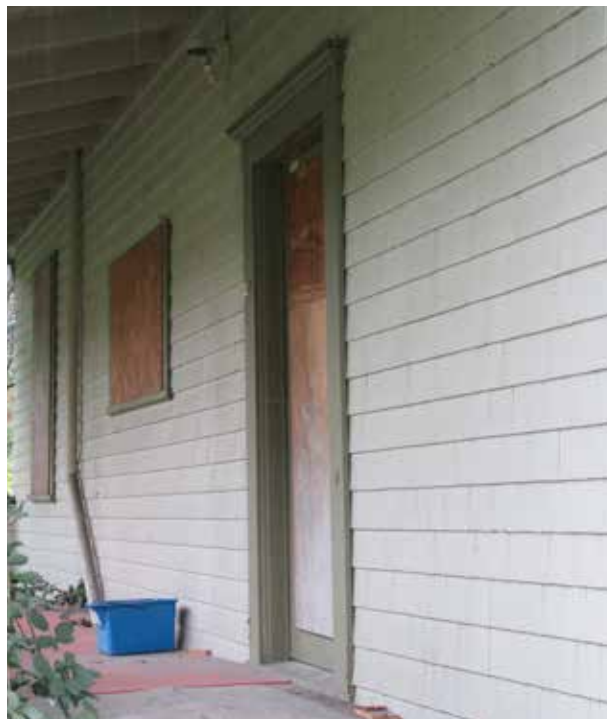
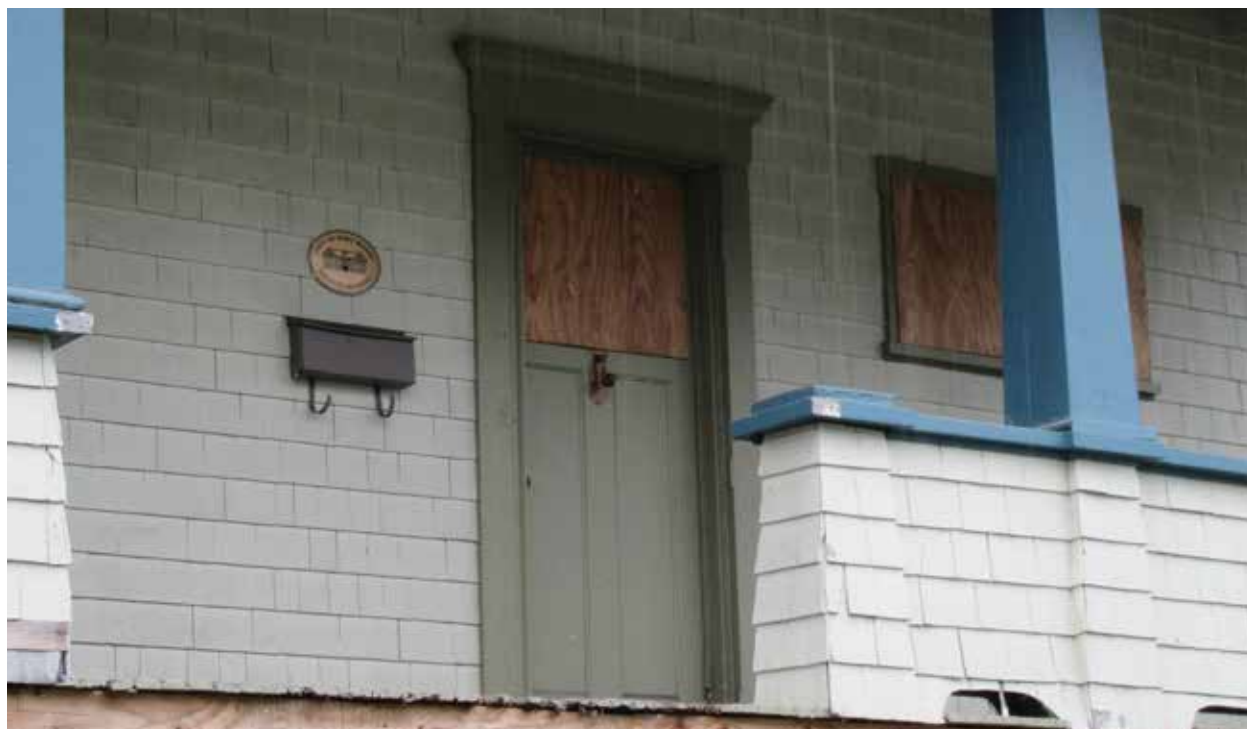
The original front door of the Moisio Residence is still in place. The panelled front door has an upper glazing element with six true divided lites. The rear door is presently boarded up, but was reportedly in place before relocation and is a panelled wooden door. Original wide trim boards and crown mouldings exist at both door openings and should be preserved.

Top: Rear door; Bottom: Front door

- Preserve original front and surrounding trim and mouldings of both door openings, if possible.
- If the front door is being retained, verify that the door fits properly in its frame and joints are tight. Verify that hardware is operational, particularly that hinges are tight and hinge pins not worn. Remove built-up paint at door and jamb. Repair damaged elements to match original. To reduce air infiltration, weather stripping can be installed between door and frame.
- New doors should be sympathetic to the historic character of the house.

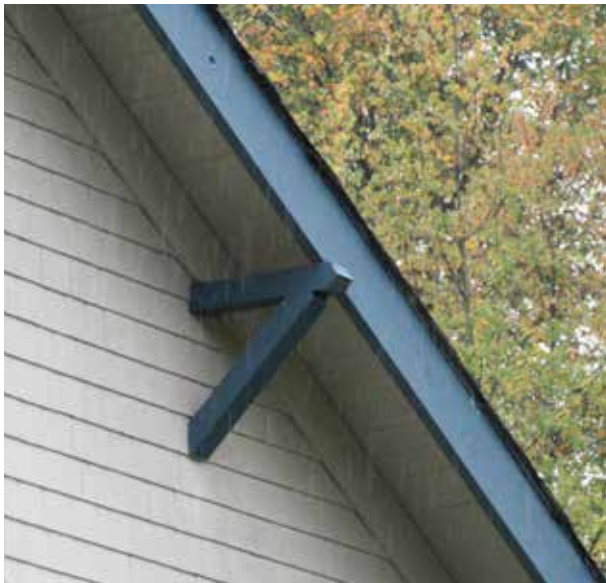
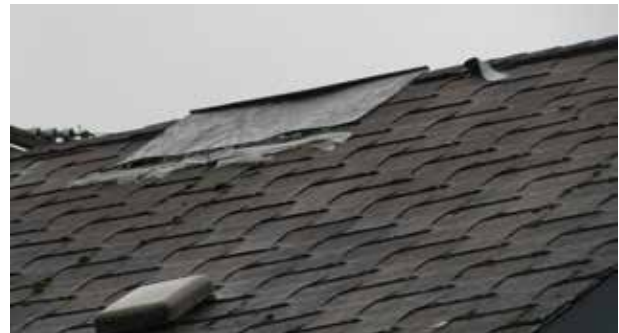
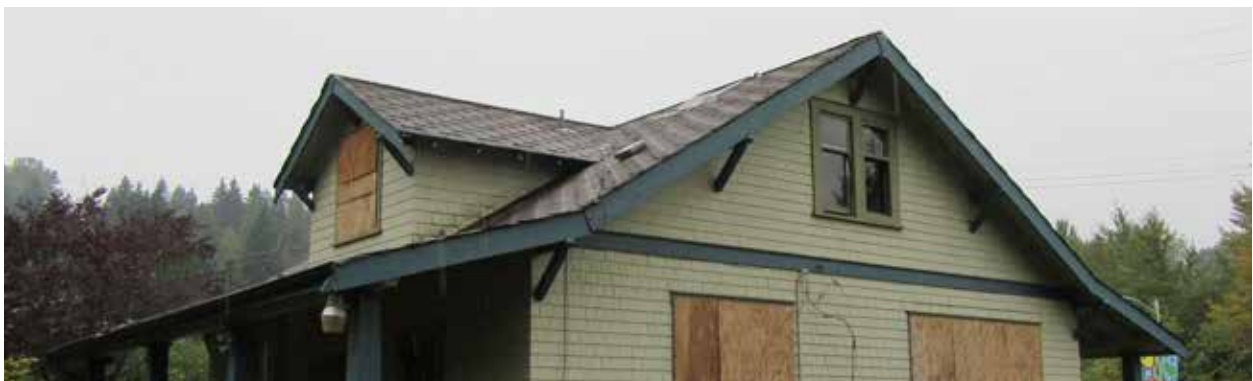
The original roof design of the Moisio Residence consists of a side-gabled main roof and dormers at the front and rear elevations. Triangular eave brackets are supporting the wide overhangs. The existing roof is presently covered with asphalt shingles, which replaced the original cedar shingles. Some debris and organic growth is visible in certain locations and would require to re-shingle the roof as part of the proposed conservation work. The existing gutters and downspouts are in fair condition and can be replaced.

Clockwise from top left: bracket and soffit; tarp covering the chimney roof opening; and overall roof structure

The original internal common-red brick chimney was removed prior to relocation. The roof opening is currently covered with tarp to prevent water ingress. As part of the conservation work the brick chimney may be rebuilt including the brick corbelling as part of the architectural features of the house.

- Preserve the historic roof design including front and rear dormers, if possible.
- The roof can be resingled with cedar shingles. An alternate material is 'Enviroshingle Silvered Cedar' by Enviroshake or approved equivalent. Asphalt roof shingles may also be acceptable for full resingling or to replace damaged existing shingles. The recommended colours for asphalt shingles are dark grey or black colour after a review by the Heritage Consultant.
- Design an adequate rainwater disposal system and ensure drainage from the elevations.

- The brick chimney may be reconstructed in its original location and original dimensions as shown in photographs. Use red-common bricks and replicate corbelling detail. Install metal flashings at the base.

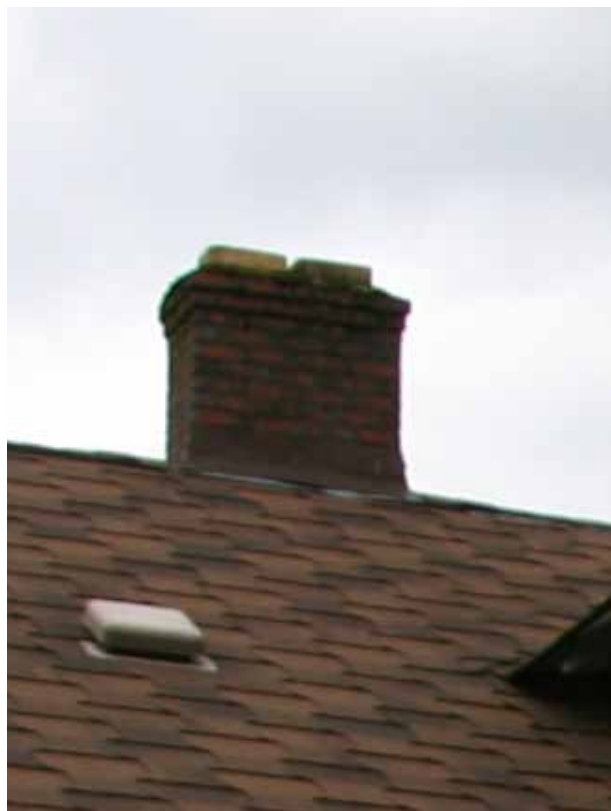
Internal brick chimney with corbelling before removal
