SIDDALL RESIDENCE

2901 ST. JOHNS STREET, PORT MOODY CONSERVATION PLAN

NOVEMBER 2015 REVISED JULY 2016

DONALD LUXTON AND ASSOCIATES INC.

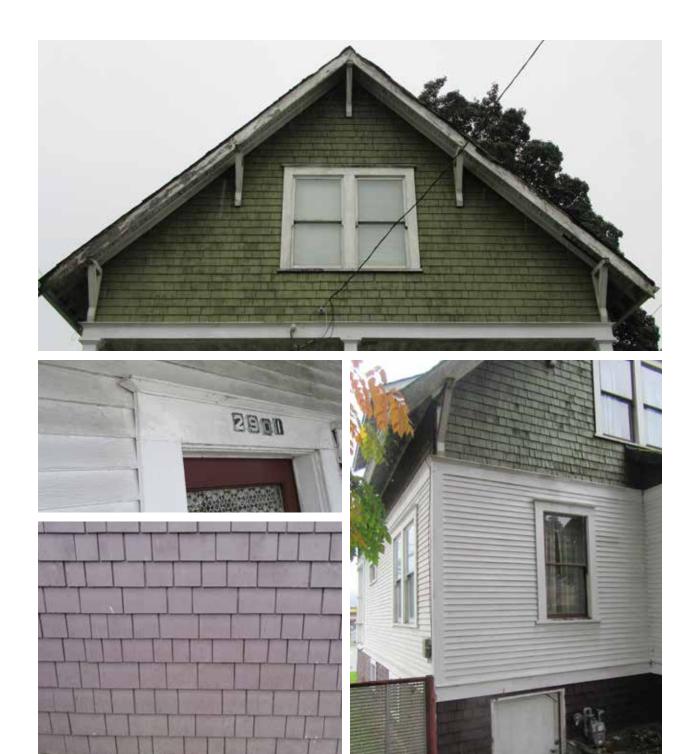
The original wood lap siding and cornerboards on the main floor is still in place and in good condition except for peeling paint.

At the basement level and the elevations above the second floor joists are finished with cedar shingles, which show some signs of weathering. The lap and shingle siding are important architectural elements of the house and should be preserved and restored. Severely damaged siding can be replaced with appropriate replica siding matching the original profile. The basement will be rehabilitated and new cedar shingles matching the original should be installed.

Clockwise from Top: Shingle siding at second floor; Lap siding, belt course, watertable and cornerboard; Shingle siding at basement; Door trim

Retain lap and shingle siding and cornerboards, and restore in-place. Replace any damaged lap siding to match existing in material, size, profile.

- Retain original trim that is in good or repairable condition.
- Cut out deteriorated trim sections and install matching trim board that is visually and physically compatible with the original.
- Combed or textured lumber, vinyl or fibre cement siding are not acceptable replacement materials on the historic house.

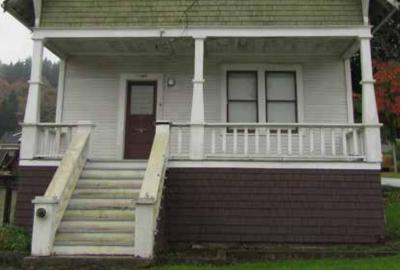
The Siddall Residence has an original full-length front porch with three tapered columns, open balustrade and tongue-and-groove flooring and soffit. Some signs of water damage and deterioration, particularly rot at the bottom of the columns, is visible.

The original wooden stair with nine treads and closed risers, starting and end newels, and handrails with banisters is still extant but is also weathered. It appears though that the treads were replaced in the past. The stair may not be salvageable due to the relocation of the house.

Clockwise from top left: Tongue and groove flooring; Tongue and groove flooring and closed riser; Front porch; Stairs with starting and end newels, and handrails with banisters

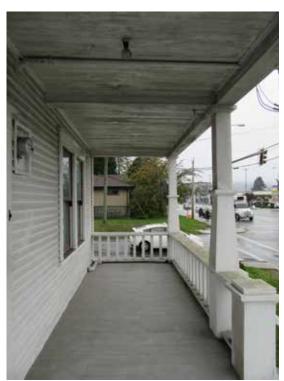
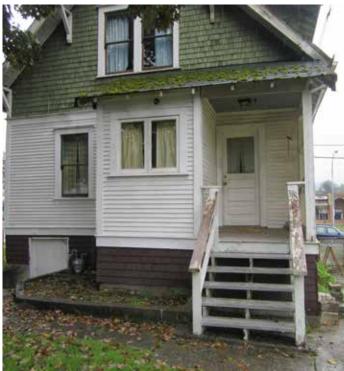
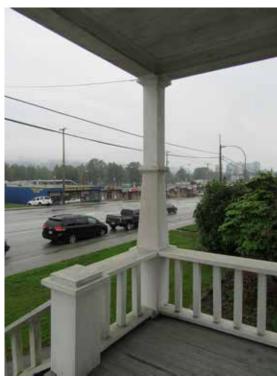
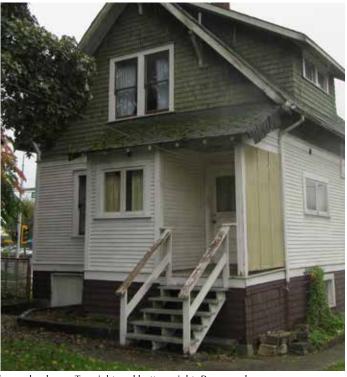
Top Left: Tongue and groove soffit and flooring; Bottom left: Tapered column; Top right and bottom right: Rear porch

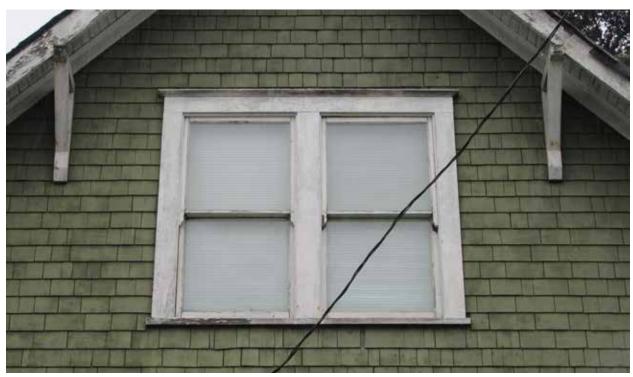
The original window assemblies of the Siddall Residence comprise mostly of pairs of original one-over-one, double hung wooden sash windows on all elevations. They show the typical sash horns, a historic detail of these window types. Other window configurations include a piano window with leaded and stained glass on the west elevation, and pairs of casement windows on the east and south elevations. The dormer on the east side features a pair of hopper windows. The original wood windows should be preserved and restored.

Pair of original one-over-one, double hung wooden sash windows on second storey of front façade

- Retain the original wood sash windows in their original openings.
- Restore deteriorated or damaged wood elements where possible (e.g. sashes, sills), and replace elements that are missing or too deteriorated to be repaired.

- Overhaul, tighten/reinforce joints of original windows. Repair frame, trim and hardware.
 Each original window should be made weather tight by re-puttying and weather-stripping as necessary.

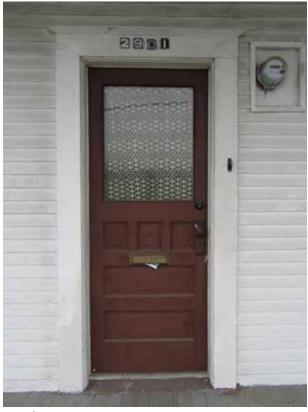
Front door

The house has two original doors on the front and rear elevations. The doors are similar in their design with multi-panelling in the lower section and glazing above. These doors should be retained if possible. On the east elevation a later basement door exists, which will be removed as part of the proposed relocation of the house.

- Preserve the original door opening, front and surrounding trim. Retain the rear door if possible.
- To improve operation, verify that door fits properly in its frame and joints are tight. Verify that hardware is operational, particularly that hinges are tight and hinge pins not worn.
 Remove built-up paint at door and jamb. Repair damaged elements to match original. To reduce air infiltration, install weather stripping between door and frame.
- New doors should be sympathetic to the historic character of the house and made of wood.

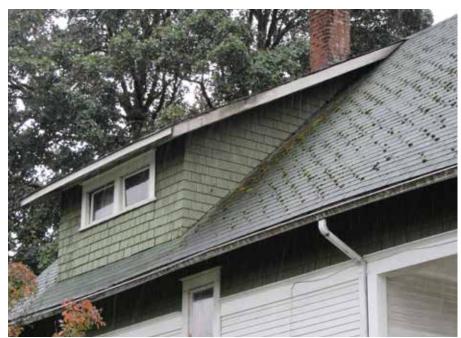
Chimney

An original internal chimney built with common red brick exists. A concrete cap and metal flashings were installed later. When viewed from the ground the brick chimney shows signs of weathering including significant organic growth, deteriorated mortar, failing flashings etc. Further assessments of the condition of the brickwork should be carried out when access is available. The brick chimney is a character-defining element and should be relocated with the house.

- The existing brick chimney should be retained in place and relocated with the house, if possible.
- The brickwork can be gently cleaned of dirt and the brickwork re-pointed as necessary with suitable mortar. The brickwork will remain unpainted.
- If the condition of the brick chimney is too deteriorated to be repaired, it should be carefully dismantled and bricks salvaged and used as examples for replacement bricks. A new chimney should be built to match the original in dimensions, material, and colour.
- New metal flashings should be installed.
