SUTHERLAND RESIDENCE

2830 ST. GEORGE STREET, PORT MOODY

CONSERVATION PLAN

NOVEMBER 2015 REVISED JULY 2016

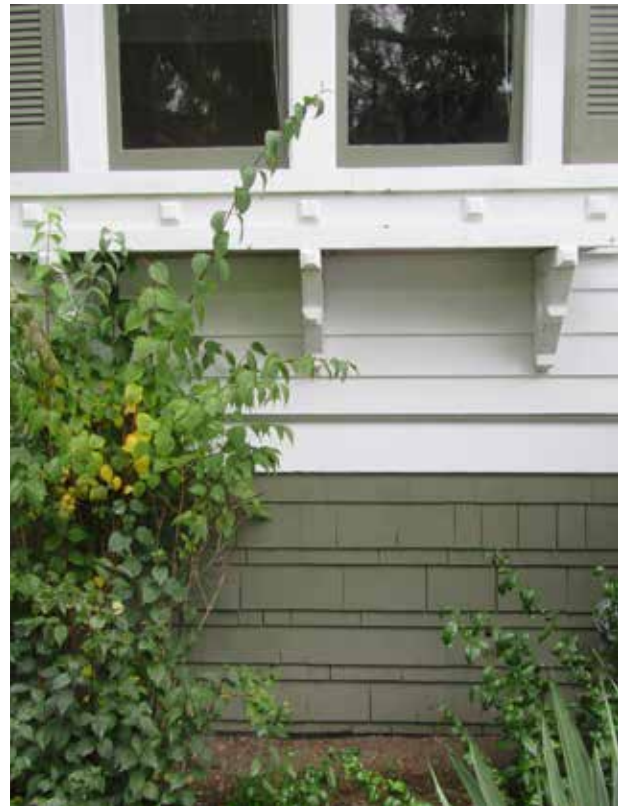
The Sutherland Residence has a full basement consisting of poured-in-place concrete foundation walls and concrete slab. The basement level finished with cedar shingles in double-coursed pattern that show signs of weathering. During the relocation process the house will be lifted at the first floor joists and placed onto new concrete foundations at the new subdivided lot while the existing concrete foundation will be demolished.

Shingle-clad foundation wall

- It is proposed to relocate the historic house to a subdivided lot a 123 Douglas Street in Moody Centre.
- Install new cedar shingles in double-coursed pattern to match the original appearance.
- New door and window openings at the basement level can be designed. They should be sympathetic to the historic character of the house and made of wood.
- To ensure the prolonged preservation of the new foundations, all landscaping should be separated from the foundations at grade by a course of gravel or decorative stones, which help prevent splash back and assist drainage.

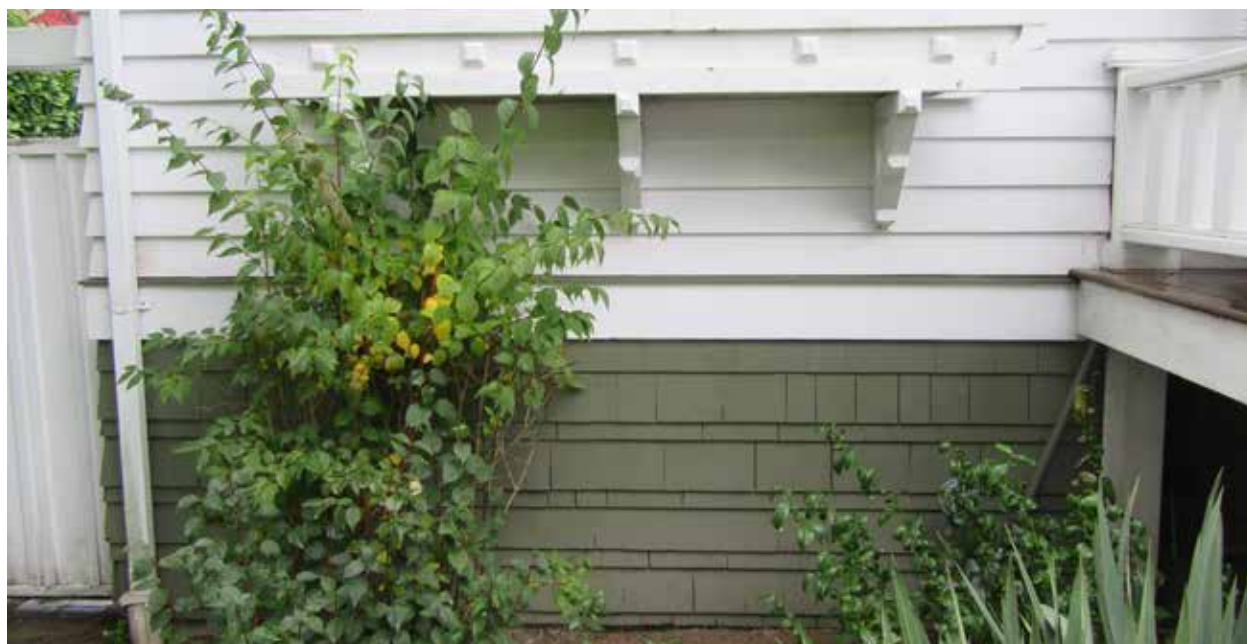
The original lapped wooden siding on the main and second floors is still in place and in very good condition. The lapped siding should be preserved and restored. Severely damaged lap siding can be replaced with appropriate replica siding matching the original profile and material. The double-coursed

Variety of siding types on the Sutherland Residence

- Retain lap siding and restore in-place. Replace any damaged lap siding to match existing in material, size, profile.
- Combed or textured lumber, vinyl or fibre cement siding are not acceptable replacement materials on the historic house.
- Cleaning procedures of lap siding should be undertaken with non-destructive methods. Areas can be cleaned using a soft, natural bristle brush, without water, to remove dirt and other material. If a more intense cleaning is required, this can be accomplished with warm water, mild detergent (such as Simple Green) and a soft bristle brush. High-pressure power washing, abrasive cleaning or sandblasting should not be allowed under any circumstances on any historic material of the exterior elevations.
- Install new double-coursed cedar shingles at the basement level matching the originals in overall dimensions and installation pattern.

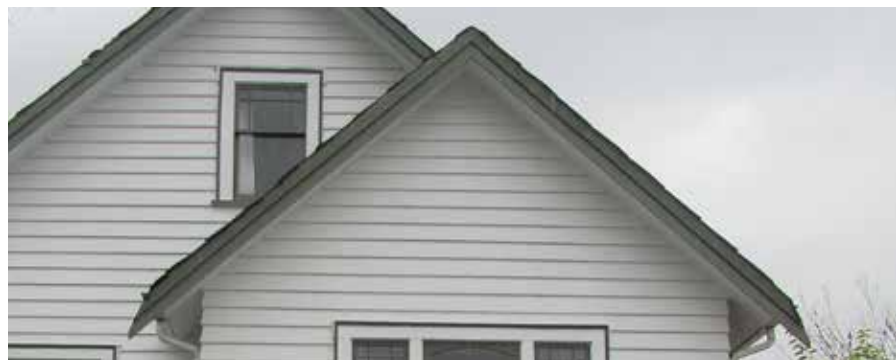
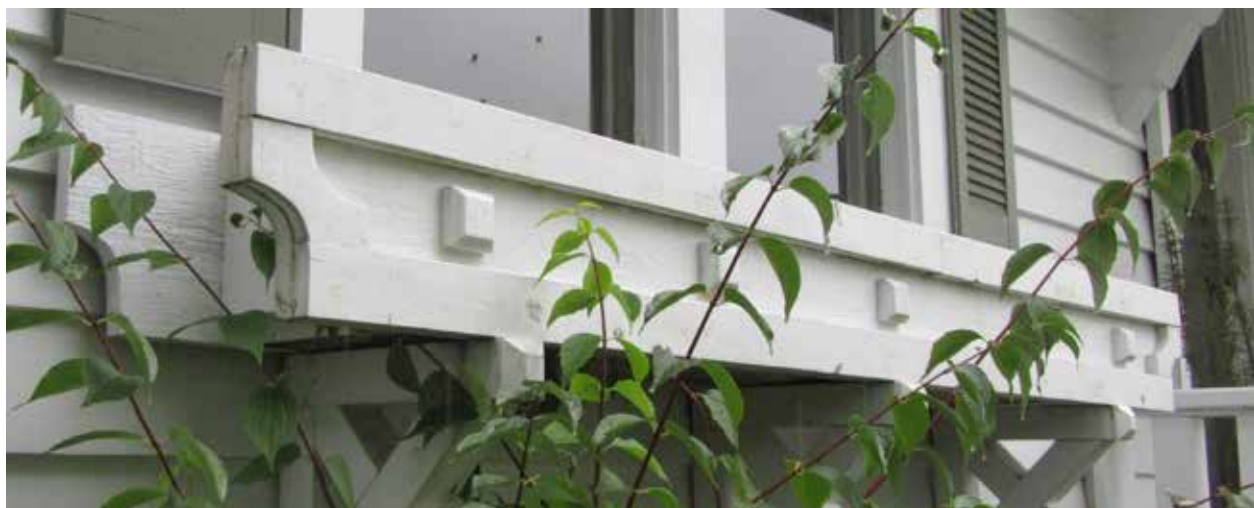
Original wood trim is visible on the elevations including window and door trim, watertable, fascia and bargeboards, which are architectural elements and will be preserved and restored as required. Damaged or deteriorated wood elements should be replaced in kind. The watertable may be removed due to the proposed relocation of the house.

On the front facade an interesting detail are two wood planter boxes below the main floor windows. They are supported by feature triangular wooden brackets. It appears that recent repairs were carried out with combed lumber, which is not an original material. The overall condition of the planter boxes is very good and they should be preserved and moved with the house.

Right: Wooden window trim and bargeboards
Bottom: Planter box

- Retain original trim including fascia and bargeboards, window and door trim that is in good or repairable condition.
- Cut out deteriorated trim sections and install matching trim board that is visually and physically compatible with the original.
- If the watertable cannot be preserved, salvage and reinstated at the new location, or replicate to match the original in material and dimensions.
- Retain the wooden planter boxes on the front facade of the house and repair as necessary.
- Combed or textured lumber, vinyl or fibre cement siding are not acceptable replacement materials on the historic house.

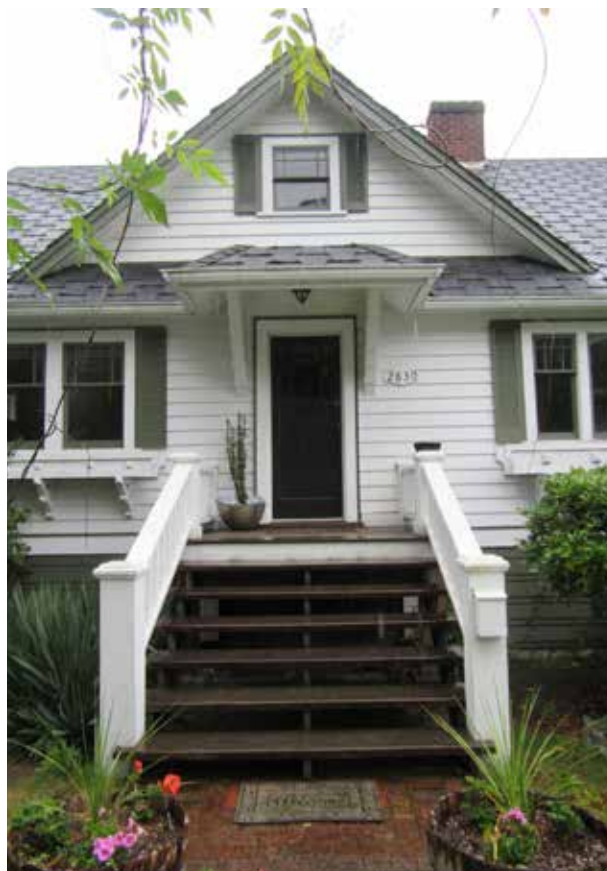
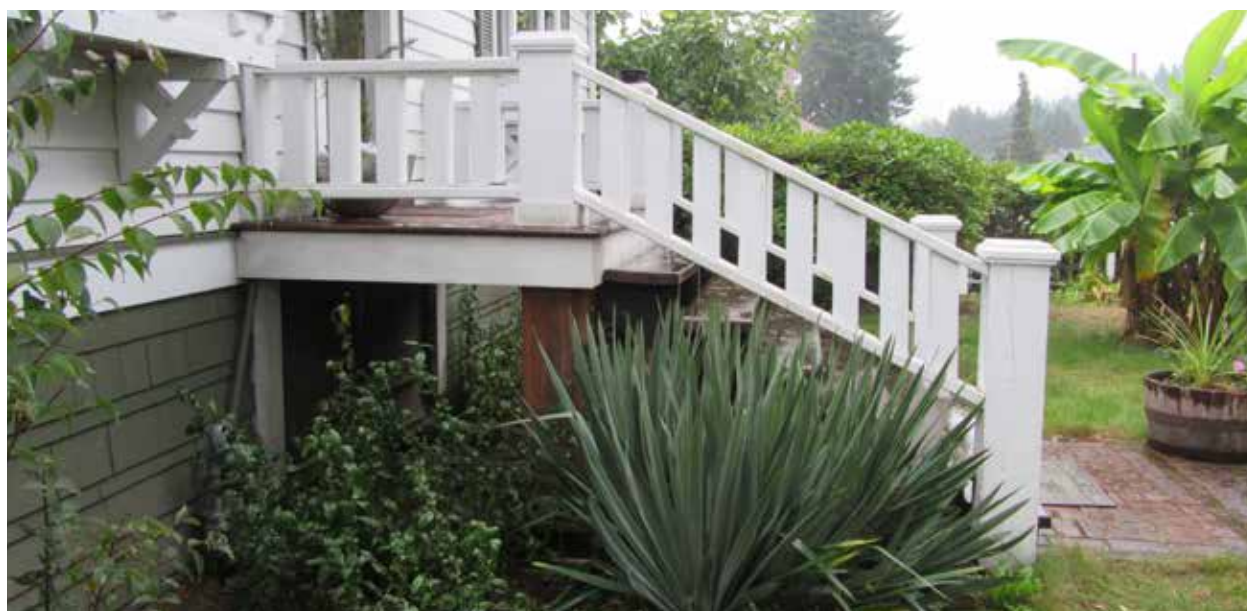
The off-centre entryway to the Sutherland Residence is located on south facade and is accessed with a rebuilt straight flight of stairs with wooden treads and open risers leading to the wooden deck. The open balustrades made of rectangular pickets and top and bottom rails retained the historic height. Starting and landing newels with wooden capitals contribute to the heritage character of the historic house. The entryway is covered with a projecting hip roof and supports on either side finished with lap siding matching the main body of the house. Due to the limited setback at the new location, the front stair will be rebuilt with matching details while the stair will be relocated to the side.

Front entryway

- Rebuild the front deck at the new location using salvaged material, if possible. Construct a new side-facing stair with wooden treads.
- The original height of the balustrade should be preserved. Only if necessary use alternate compliance method to meet building code requirements, e.g. installing glass panels or metal railings.
- Preserve the hip roof above the entry.
- Restore wood elements as required.

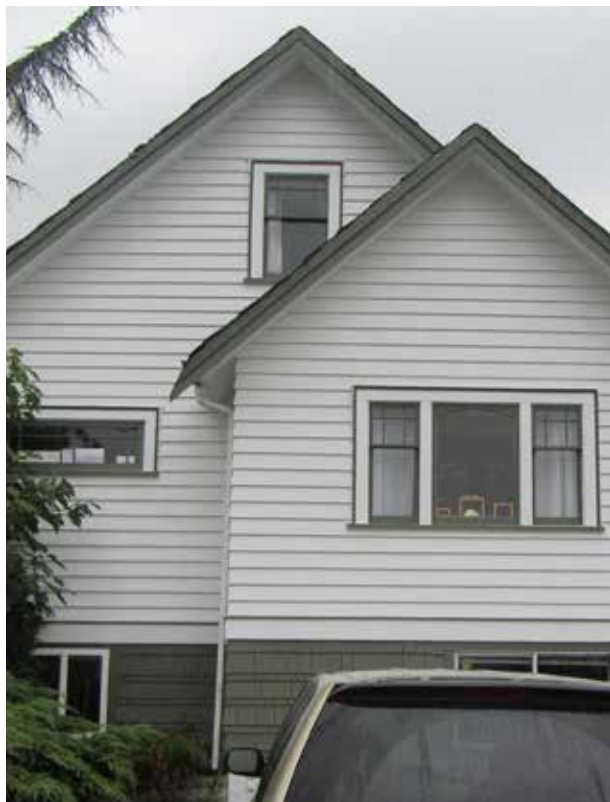
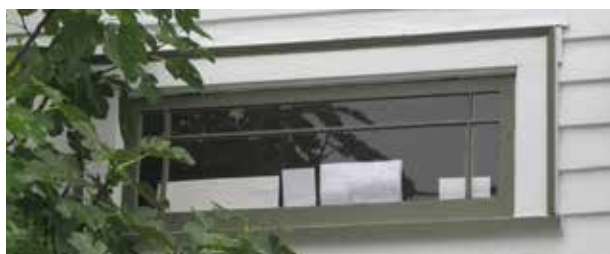
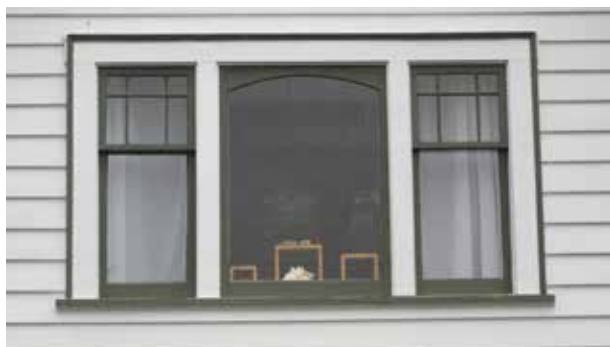
The window configurations were reviewed during site visits in October 2015 and March 2016. The house features on the front and side elevations original six-over-one double-hung, wood sash windows in single, double and tripartite configurations. The large tripartite window assemblies have a fixed centre sash with an arched header flanked by narrow double-hung sashes on either side. Multi-lite piano windows with true divided panes are also located on the side elevations. Only two windows on the rear elevation appear to be original while new door and window assemblies were introduced. Wide window trim with a surrounding moulding, thick mullions between double and tripartite assemblies, and simple wood sills are also original. The windows and trim and all in good condition when visually reviewed from the ground. The existing shutter elements on the front facade require further investigation to determine, if they are to be retained.

Window assemblies of the Sutherland Residence

- Retain the original wood sash windows in their original openings.
- Review the condition of each window and note deficiencies that require repair work.

- If deteriorated or damaged wood elements are observed restore in kind.
- Overhaul, tighten/reinforce joints of original windows as required. Repair frame, trim and hardware. Each original window should be made weather tight by re-puttying and weather-stripping as necessary.

- Retain historic glass of original windows.
- Window restoration should be undertaken by a contractor skilled in heritage restoration.
- Replicate missing windows to match original in material, dimensions and detailing, including the typical arched header where required. New windows on the rear elevation may be contemporary in style, and made of wood and double-glazing.

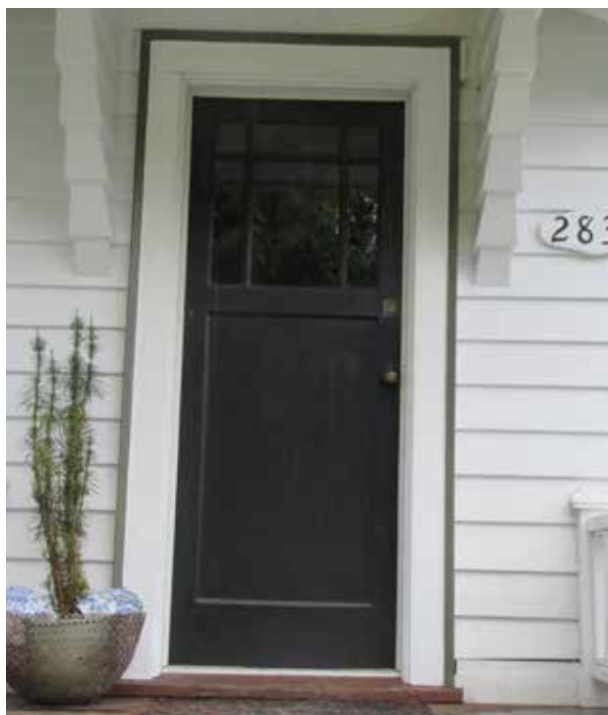
The original front door on the south facade is extant and resembles the window details with a multi-lite glazing element. Original hardware and brass doorknob with plate and lock are also in place and contribute to the heritage character of the house. This is also true for the original door trim.

Front door

- Preserve the original door opening, front door including all accessories and surrounding trim. Retain the rear door if possible.
- To improve operation, verify that door fits properly in its frame and joints are tight. Verify that hardware is operational, particularly that hinges are tight and hinge pins not worn. Remove built-up paint at door and jamb. Repair damaged elements to match original. To reduce air infiltration, install weather stripping between door and frame.
- New doors should be sympathetic to the historic character of the house and made of wood.

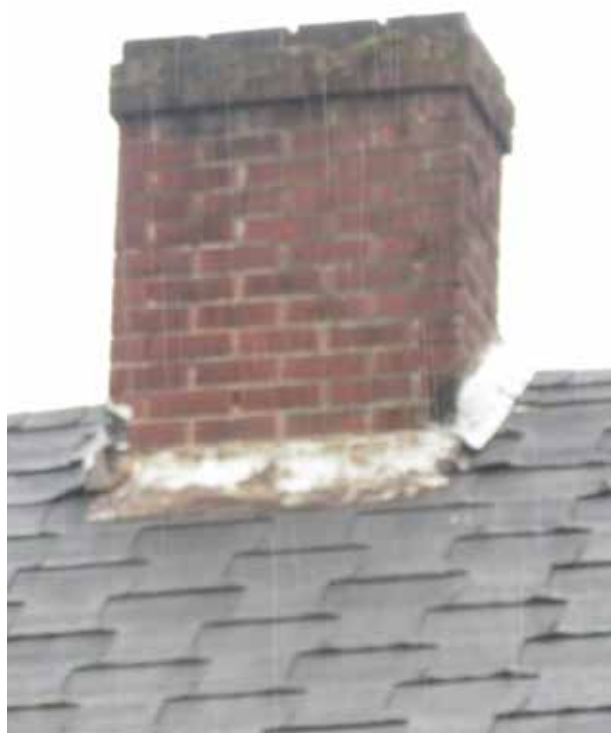
The Sutherland Residence has an internal common-red brick chimney with a simple corbelling detail at the top. The brickwork is overall in good condition and may need some cleaning and repointing. The existing metal flashings appear to be in fair condition and may be replaced if necessary.

Internal common-red brick chimney

- The existing brick chimney should be retained in place and relocated with the house.
- The brickwork can be gently cleaned of dirt and the brickwork re-pointed as necessary with suitable mortar. The brick chimney will remain unpainted.
- The condition of the existing metal flashings should be reviewed and new flashings installed as necessary.
