SUTHERLAND RESIDENCE

2830 ST. GEORGE STREET, PORT MOODY

CONSERVATION PLAN

NOVEMBER 2015 REVISED JULY 2016

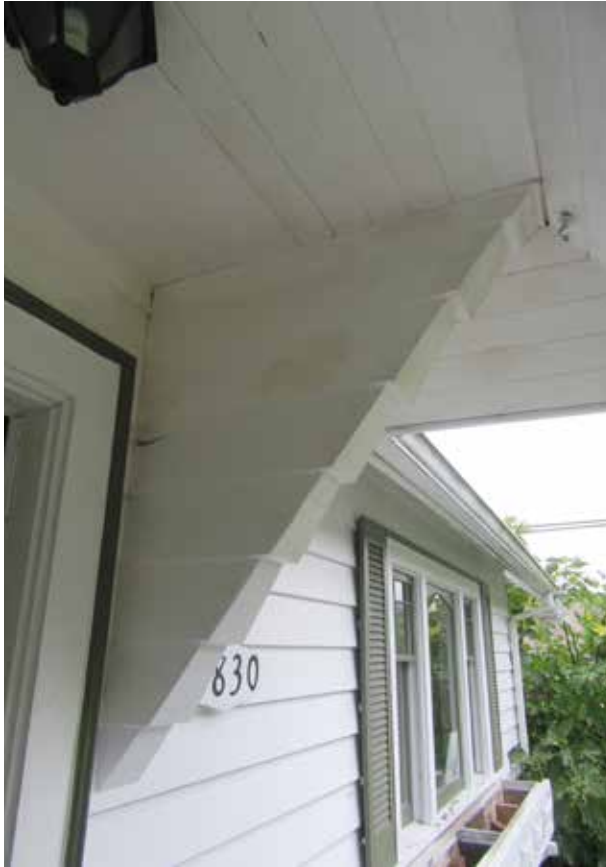
The window configurations were reviewed during site visits in October 2015 and March 2016. The house features on the front and side elevations original six-over-one double-hung, wood sash windows in single, double and tripartite configurations. The large tripartite window assemblies have a fixed centre sash with an arched header flanked by narrow double-hung sashes on either side. Multi-lite piano windows with true divided panes are also located on the side elevations. Only two windows on the rear elevation appear to be original while new door and window assemblies were introduced. Wide window trim with a surrounding moulding, thick mullions between double and tripartite assemblies, and simple wood sills are also original. The windows and trim and all in good condition when visually reviewed from the ground. The existing shutter elements on the front facade require further investigation to determine, if they are to be retained.

- The consultant can review window shop drawings and mock-ups for new windows.
- Prime and paint all wood windows as required in appropriate colours, based on colour schedule devised by the Heritage Consultant.

- Investigate if the existing shutters are original and preserve and restore. If shutters are later interventions they should be removed.

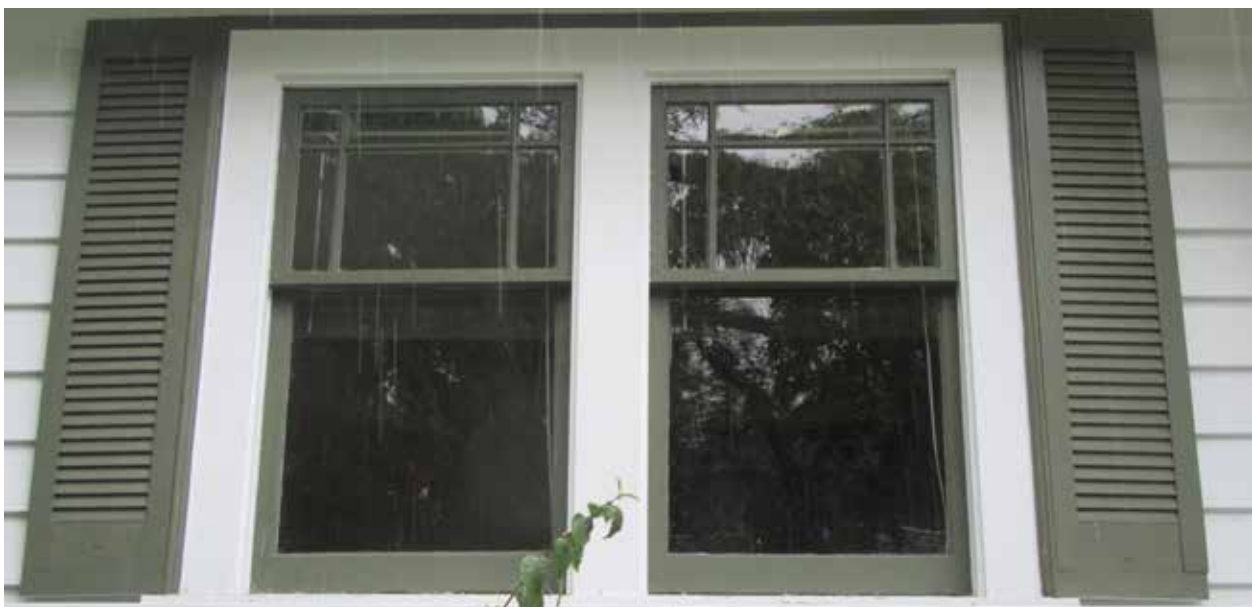
Top: Triangular siding-clad knee brackets; Bottom: Window assembly of the front facade
